# SAFETY COMPLIANCE TESTING FOR FMVSS NO. 138 TIRE PRESSURE MONITORING SYSTEMS

BAYERISCHE MOTOREN WERKE AG  
2020 BMW 330i  
FOUR-DOOR PASSENGER CAR  
NHTSA NO. C20204100

**FINAL REPORT**

1. Report No. 138-STF-20-002	2. Government Accession No.	3. Recipient's Catalog No.	
4. Title and Subtitle  Final Report of FMVSS No. 138 Compliance Testing of 2020 BMW 330i, NHTSA No.C20204100		5. Report Date February 26, 2020

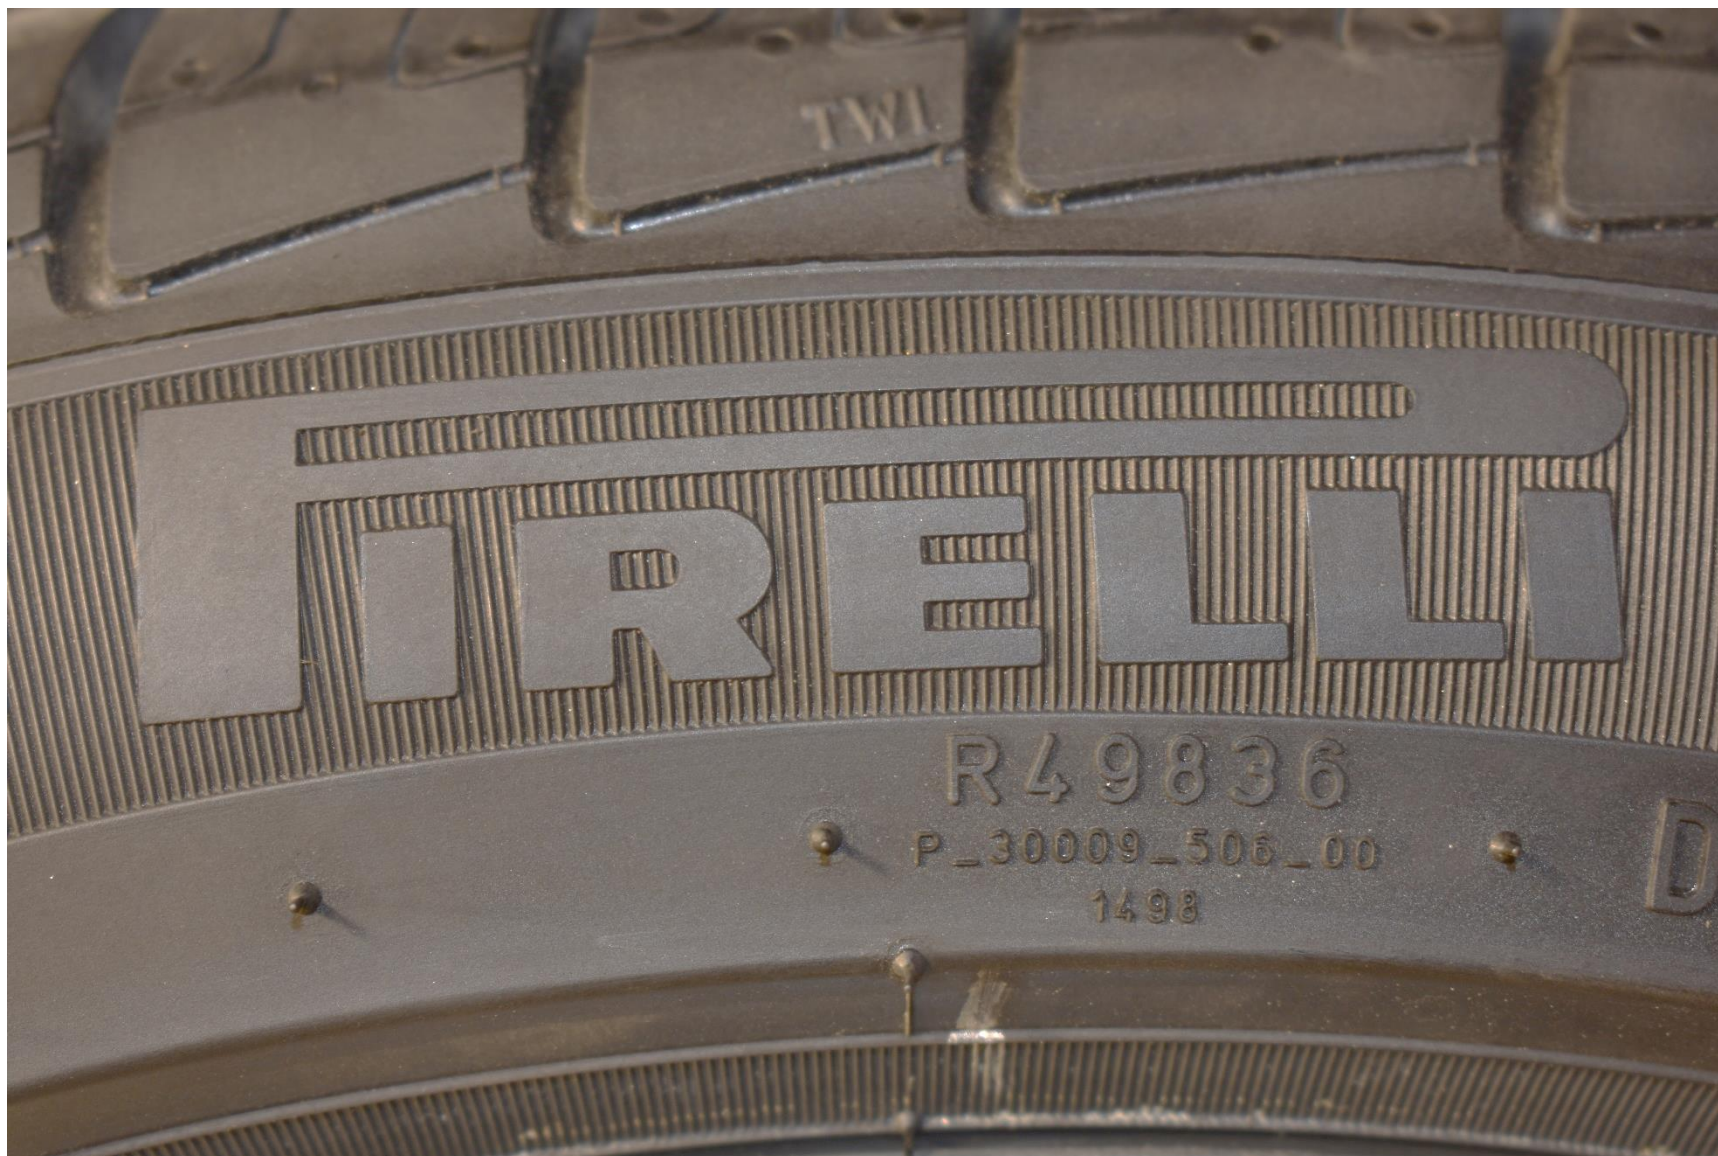
FIGURE 5.4  
TIRE SHOWING BRAND

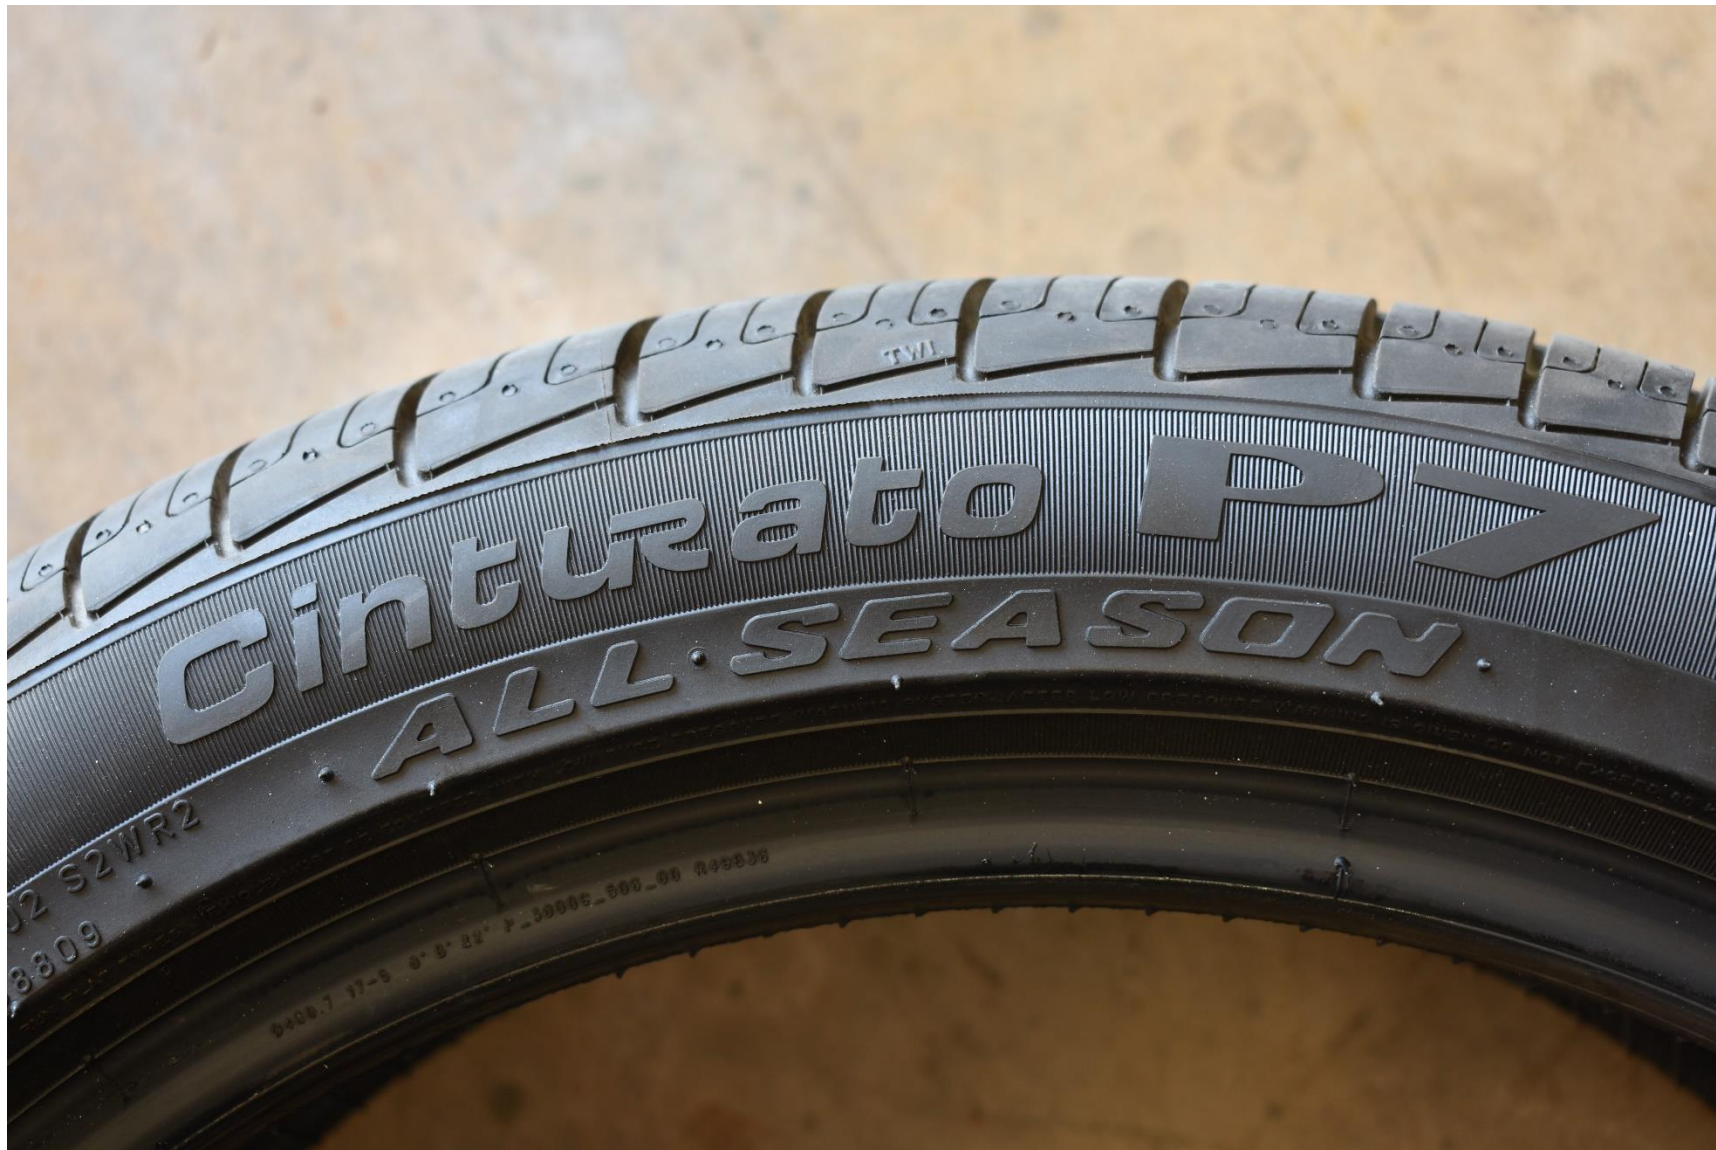
FIGURE 5.5  
TIRE SHOWING MODEL

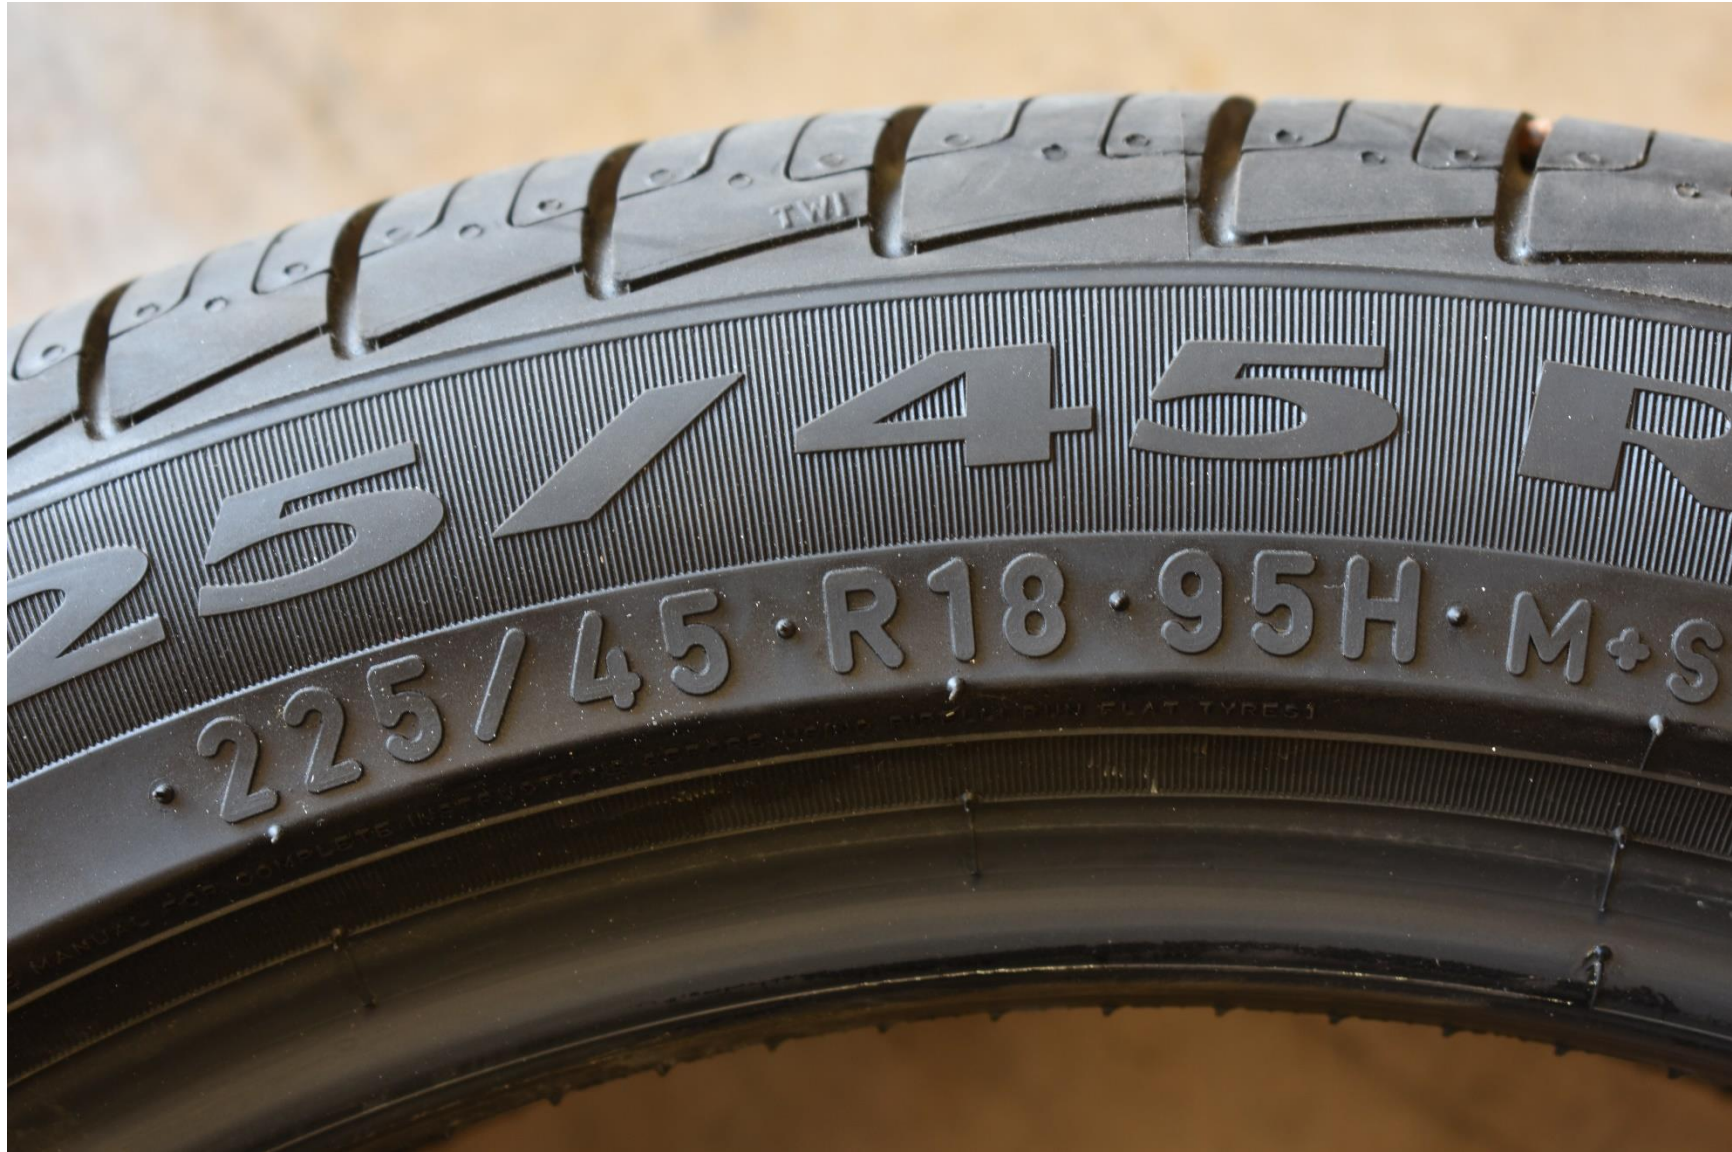
FIGURE 5.6  
TIRE SHOWING SIZE AND LOAD INDEX /SPEED RATING

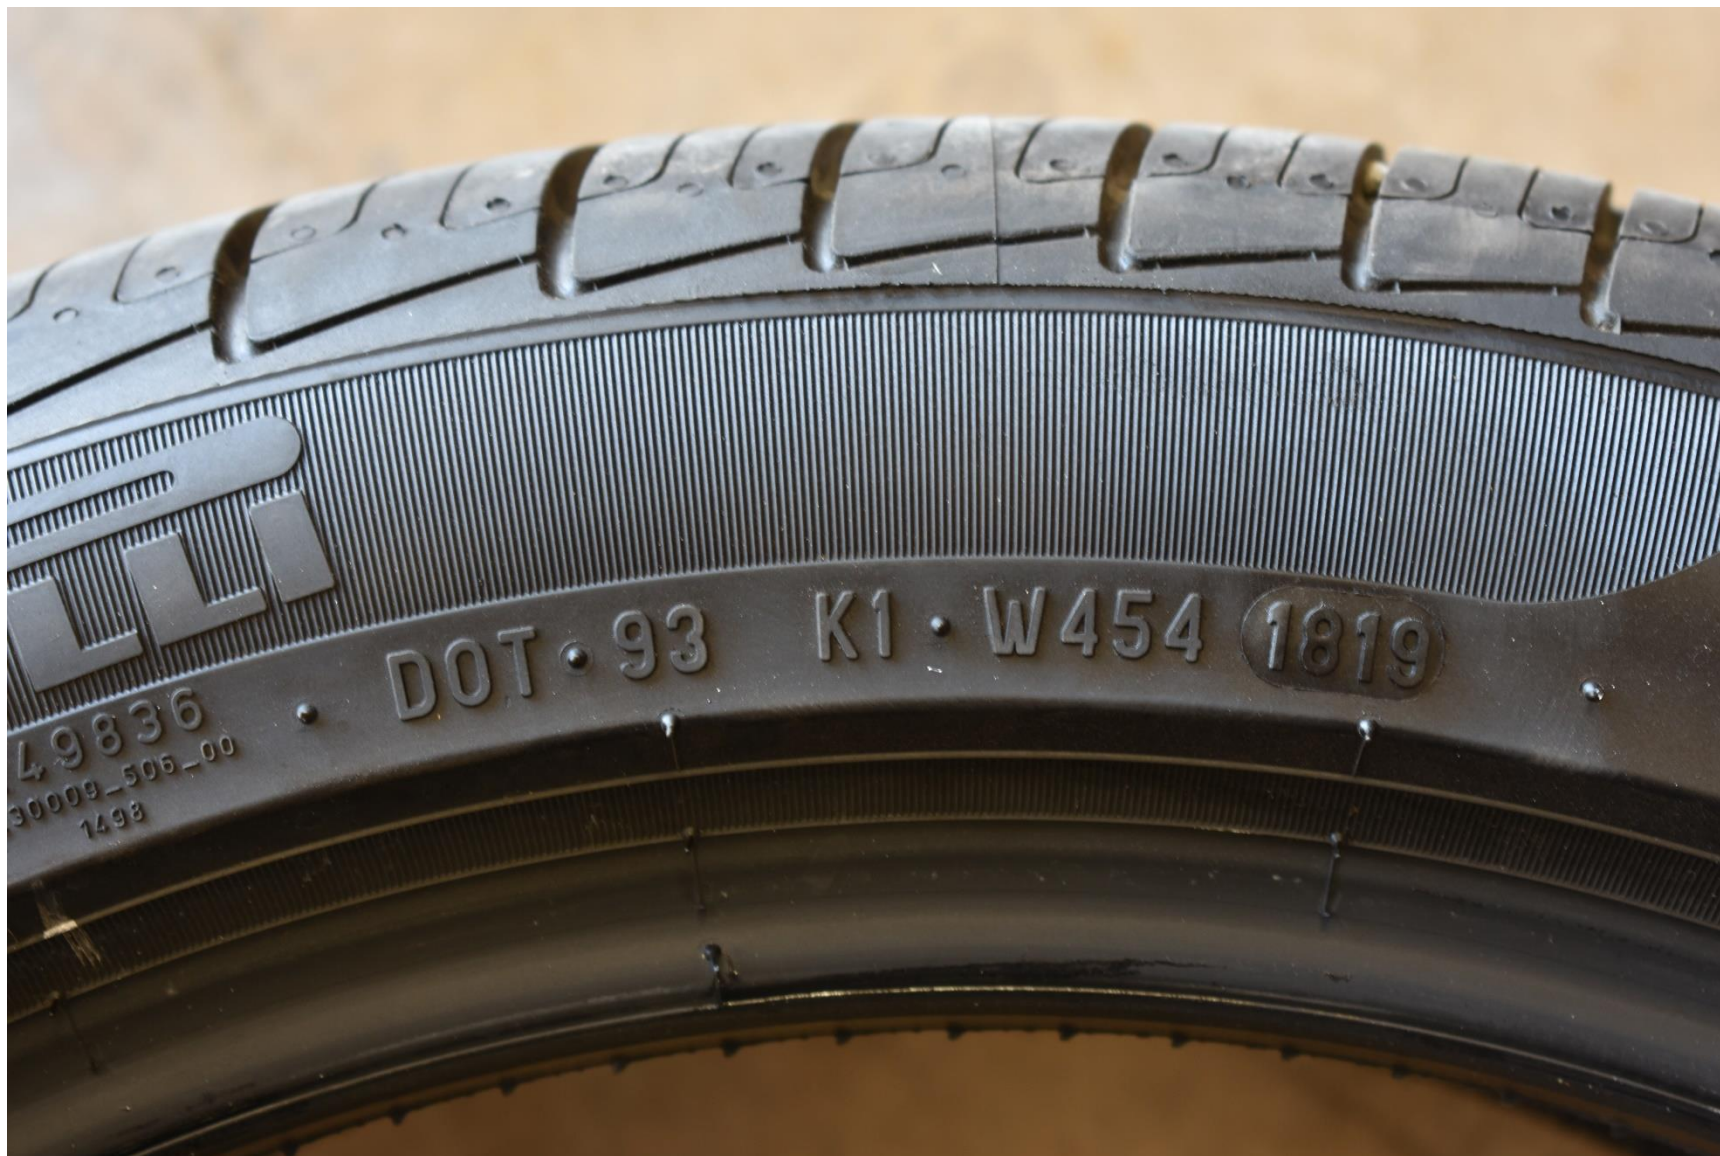
FIGURE 5.7  
TIRE SHOWING DOT NUMBER

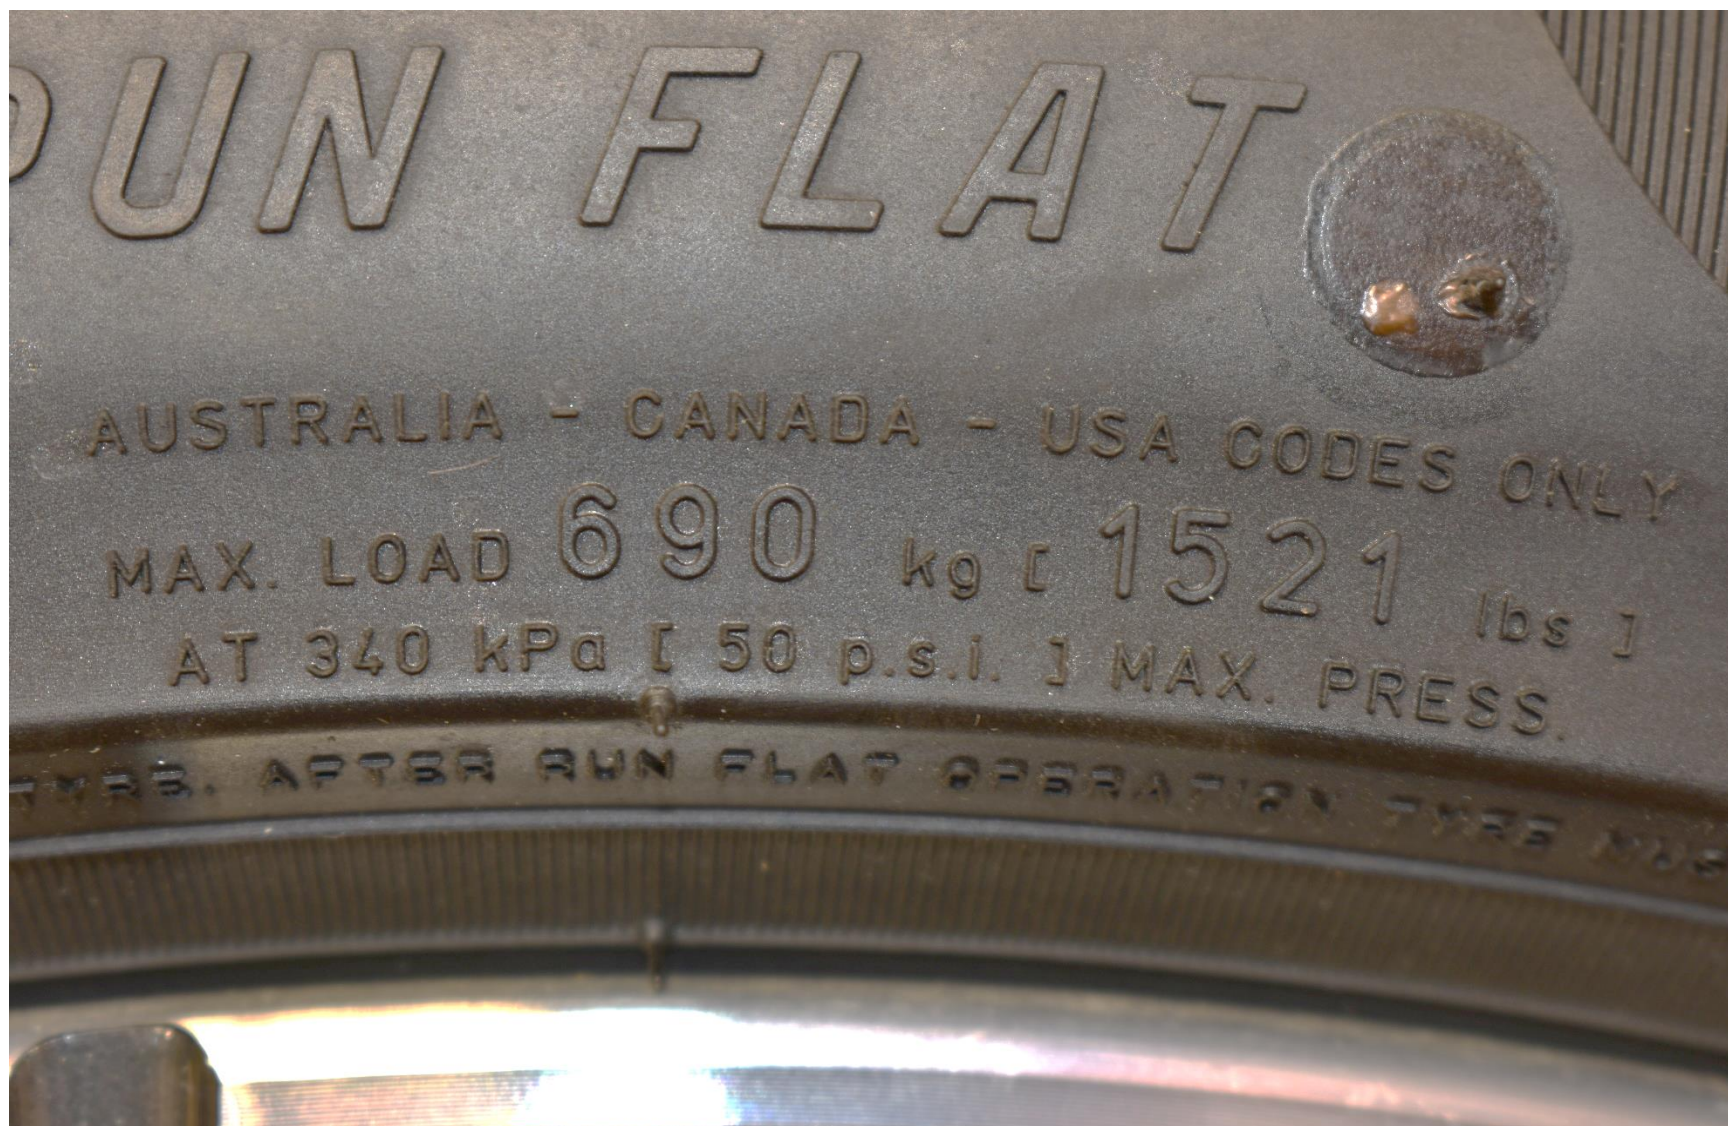
FIGURE 5.8  
TIRE SHOWING MAX LOAD RATING  
AND MAX COLD INFLATION PRESSURE

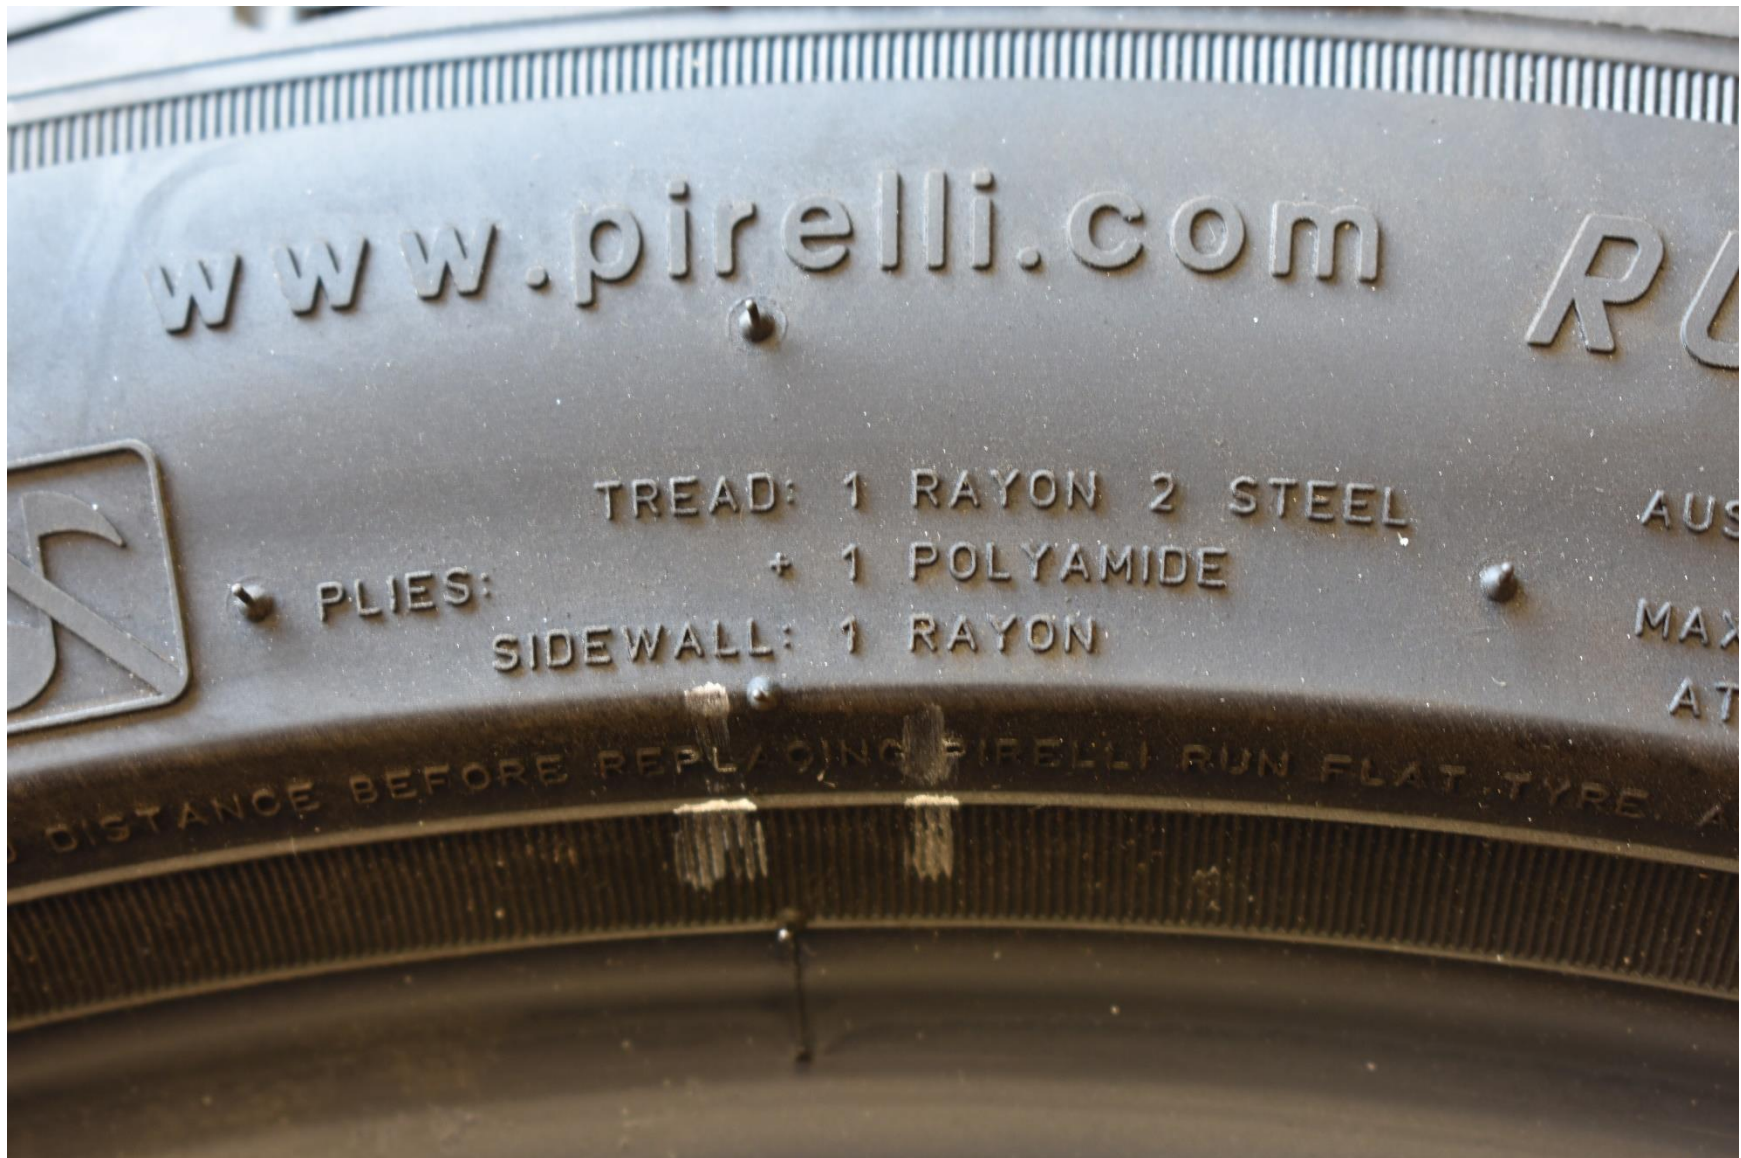
FIGURE 5.9  
TIRE SHOWING SIDEWALL / TREAD CONSTRUCTION

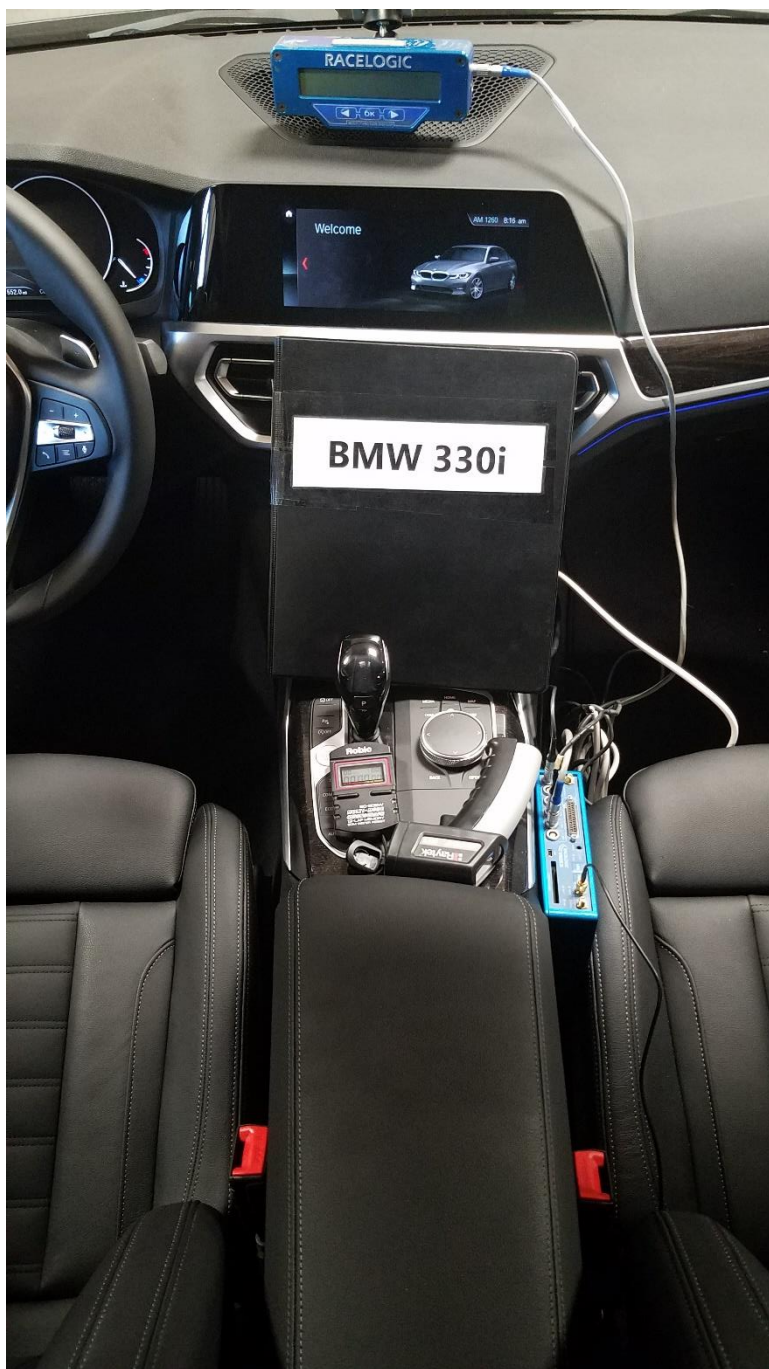
FIGURE 5.10  
TEST INSTRUMENTATION INSTALLED IN VEHICLE

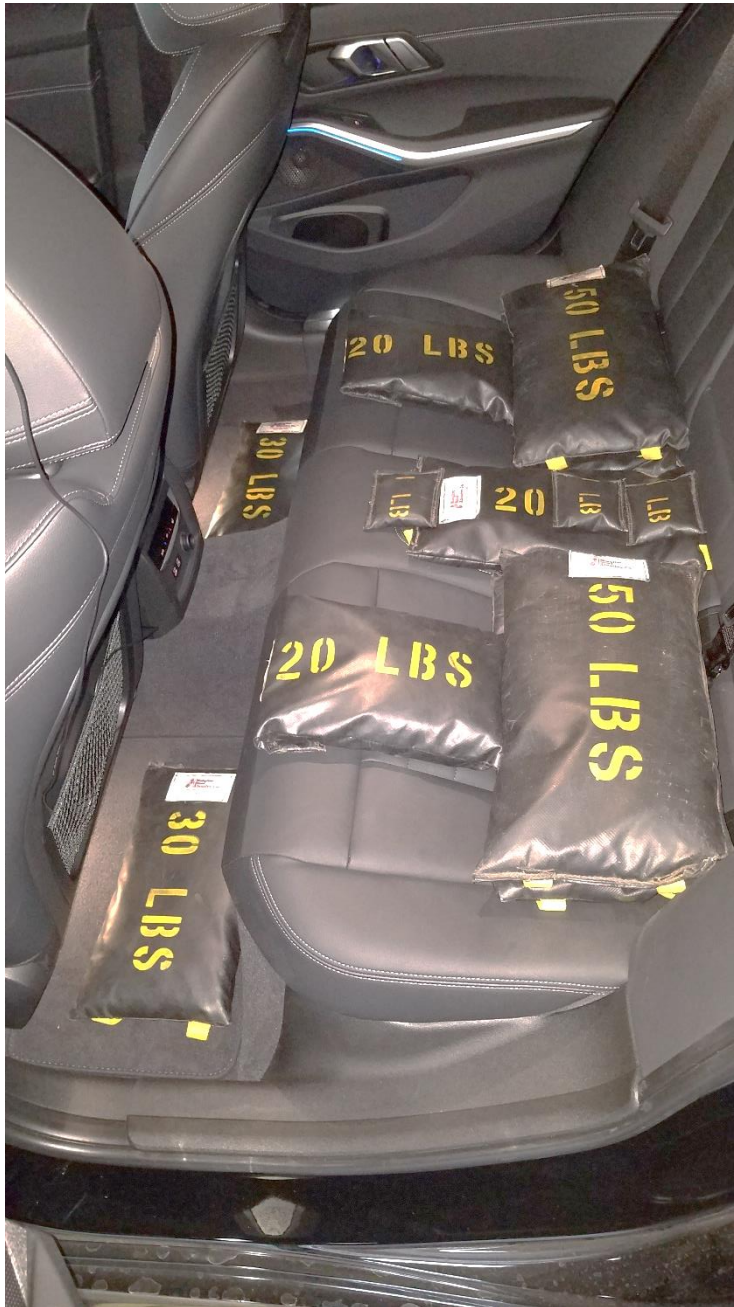
FIGURE 5.11  
REAR SEAT BALLAST FOR UVW+VCW GAWR LOAD

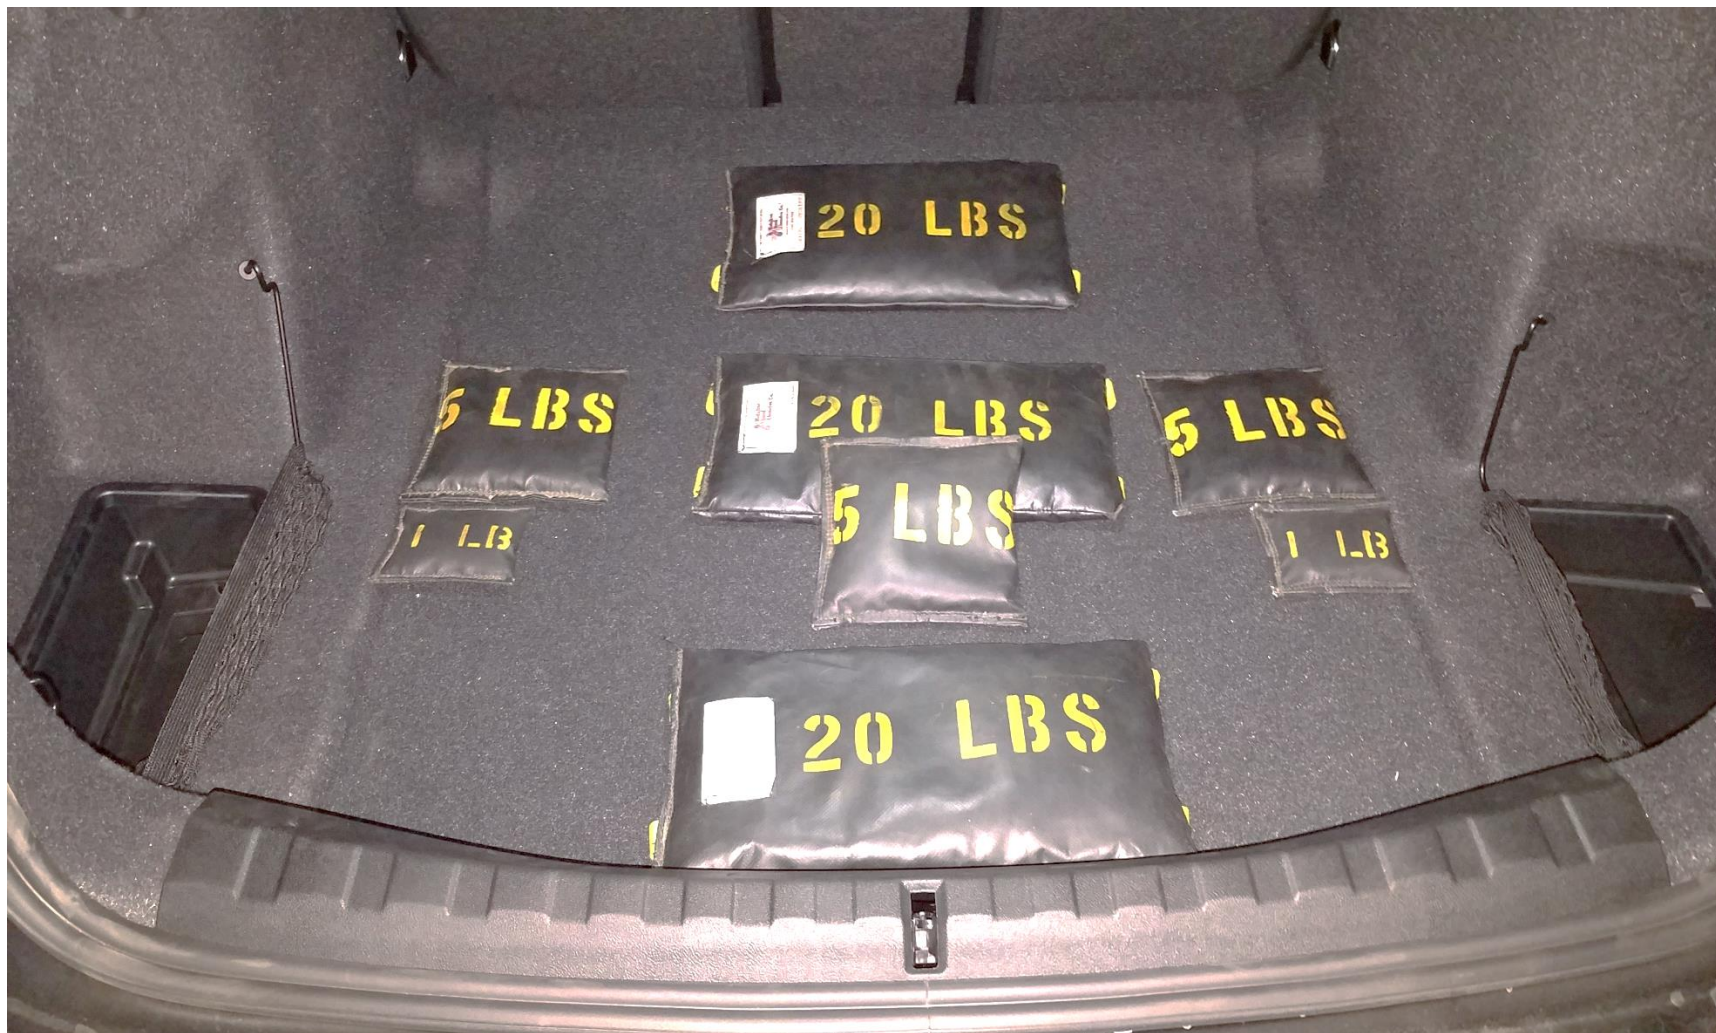
FIGURE 5.12  
VEHICLE CARGO AREA BALLAST FOR UVW+VCW GAWR LOAD

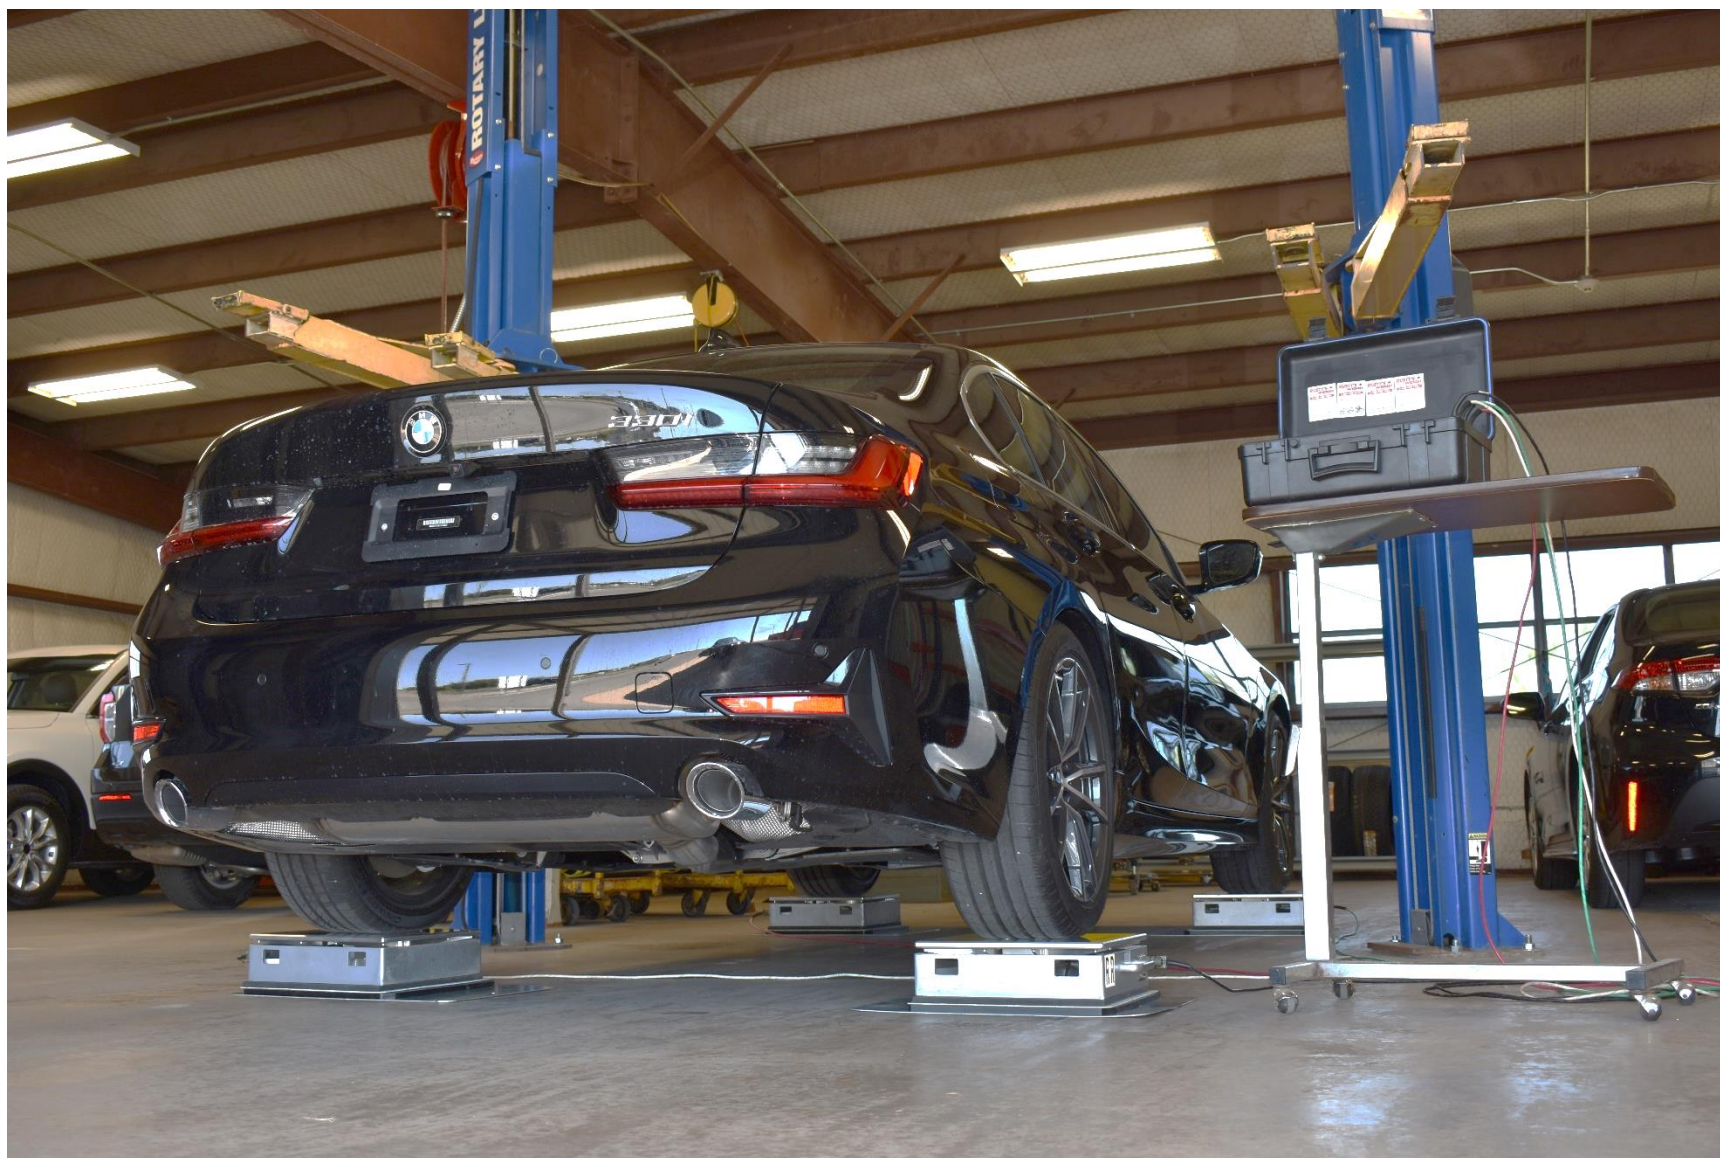
FIGURE 5.13  
VEHICLE ON WEIGHT SCALES

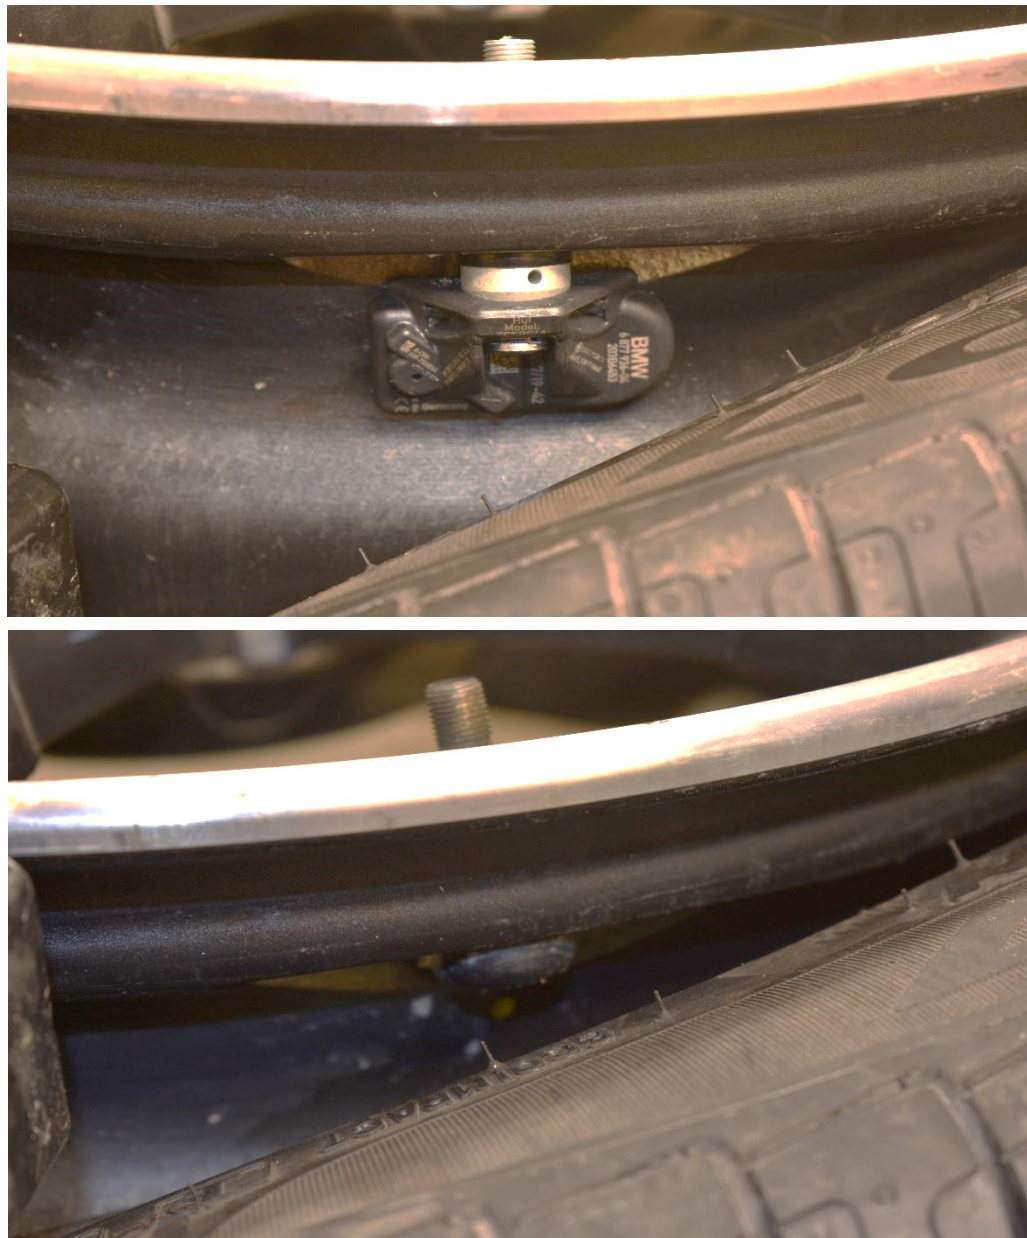
FIGURE 5.14  
MALFUNCTION DETECTION TEST 1  
TPMS RIGHT FRONT SENSOR REMOVED AT LLVW

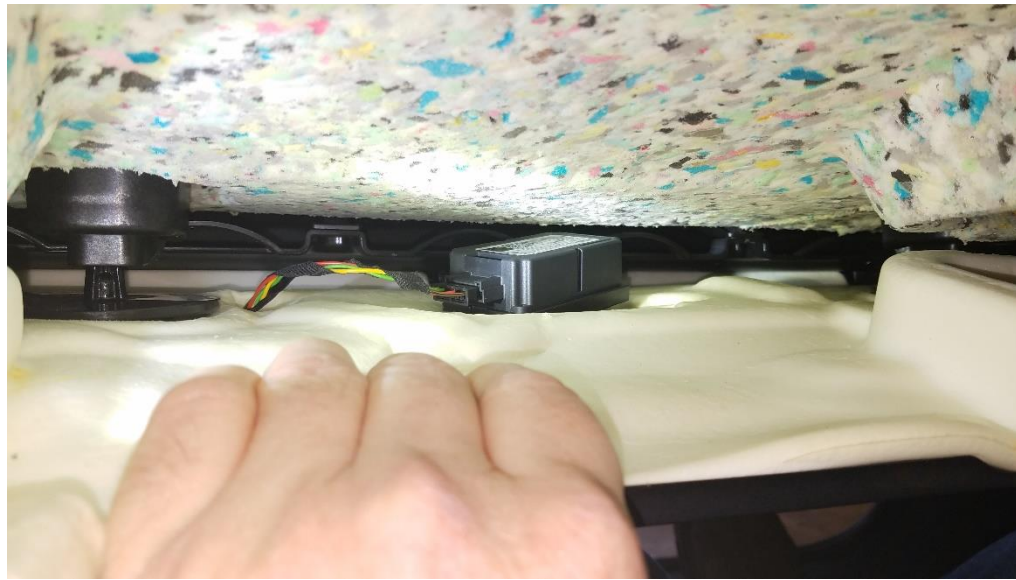
FIGURE 5.15  
MALFUNCTION DETECTION TEST 2:  
DISCONNECTED FBD4 MODULE  
(RF RECEIVER FOR TPMS SENSORS) AT UVW+VCW

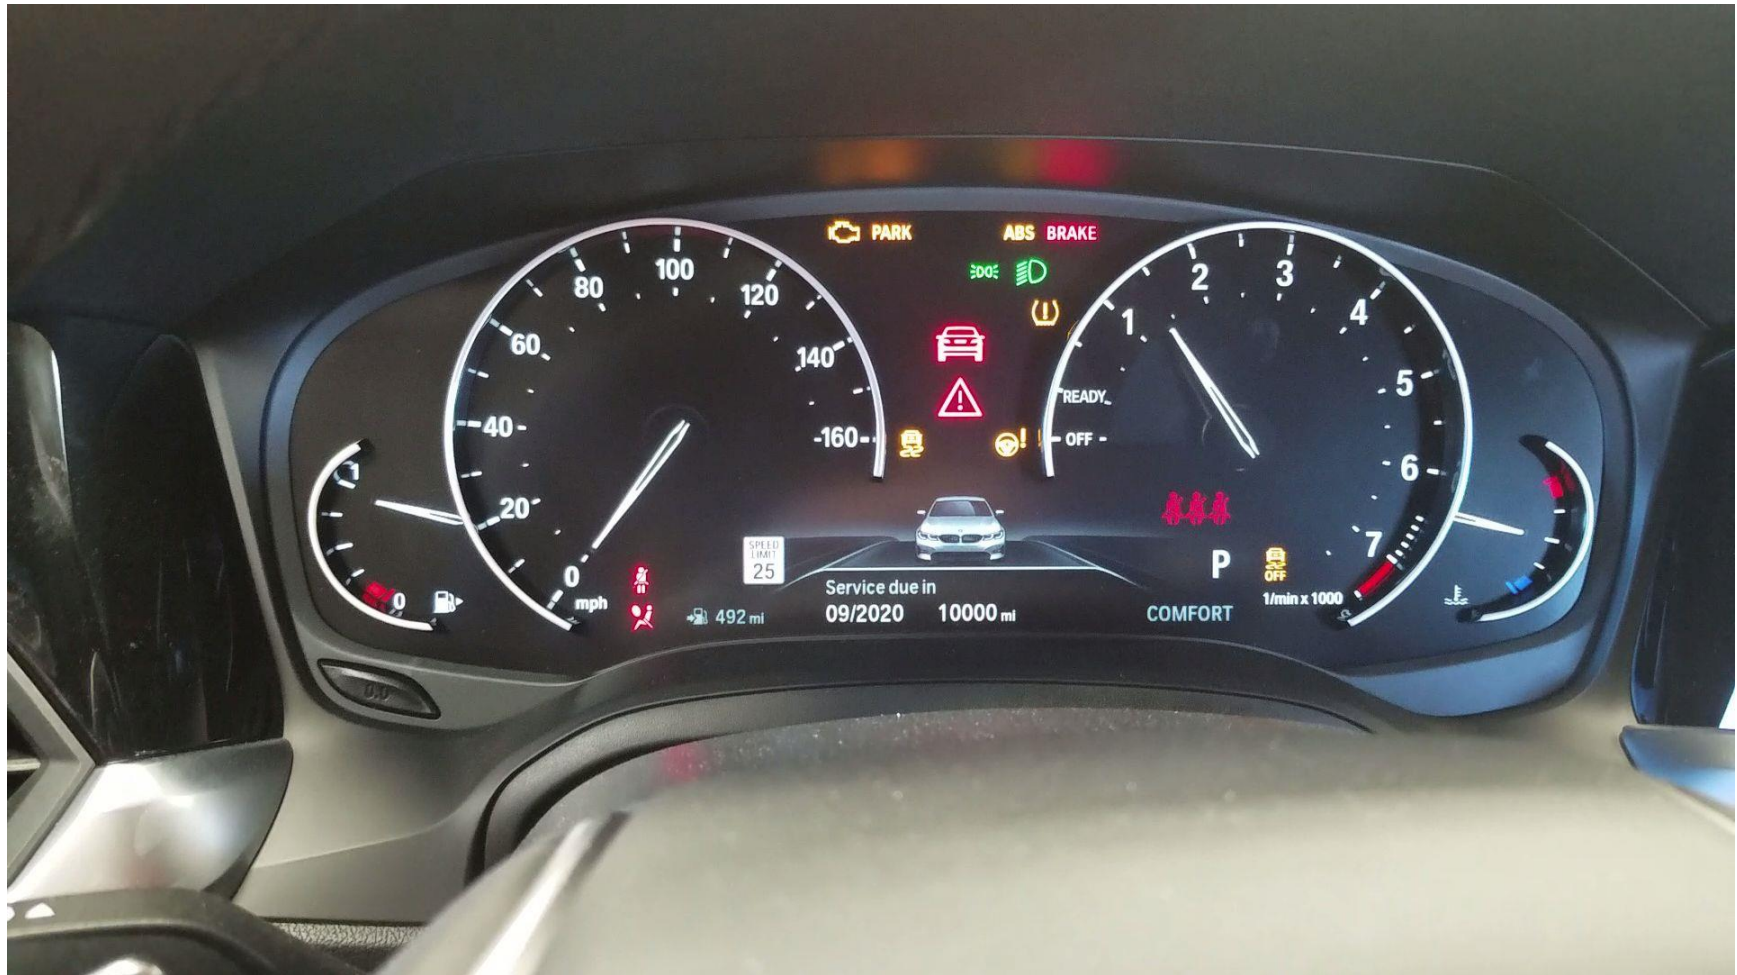
FIGURE 5.16  
VEHICLE INSTRUMENT PANEL LAMP CHECK

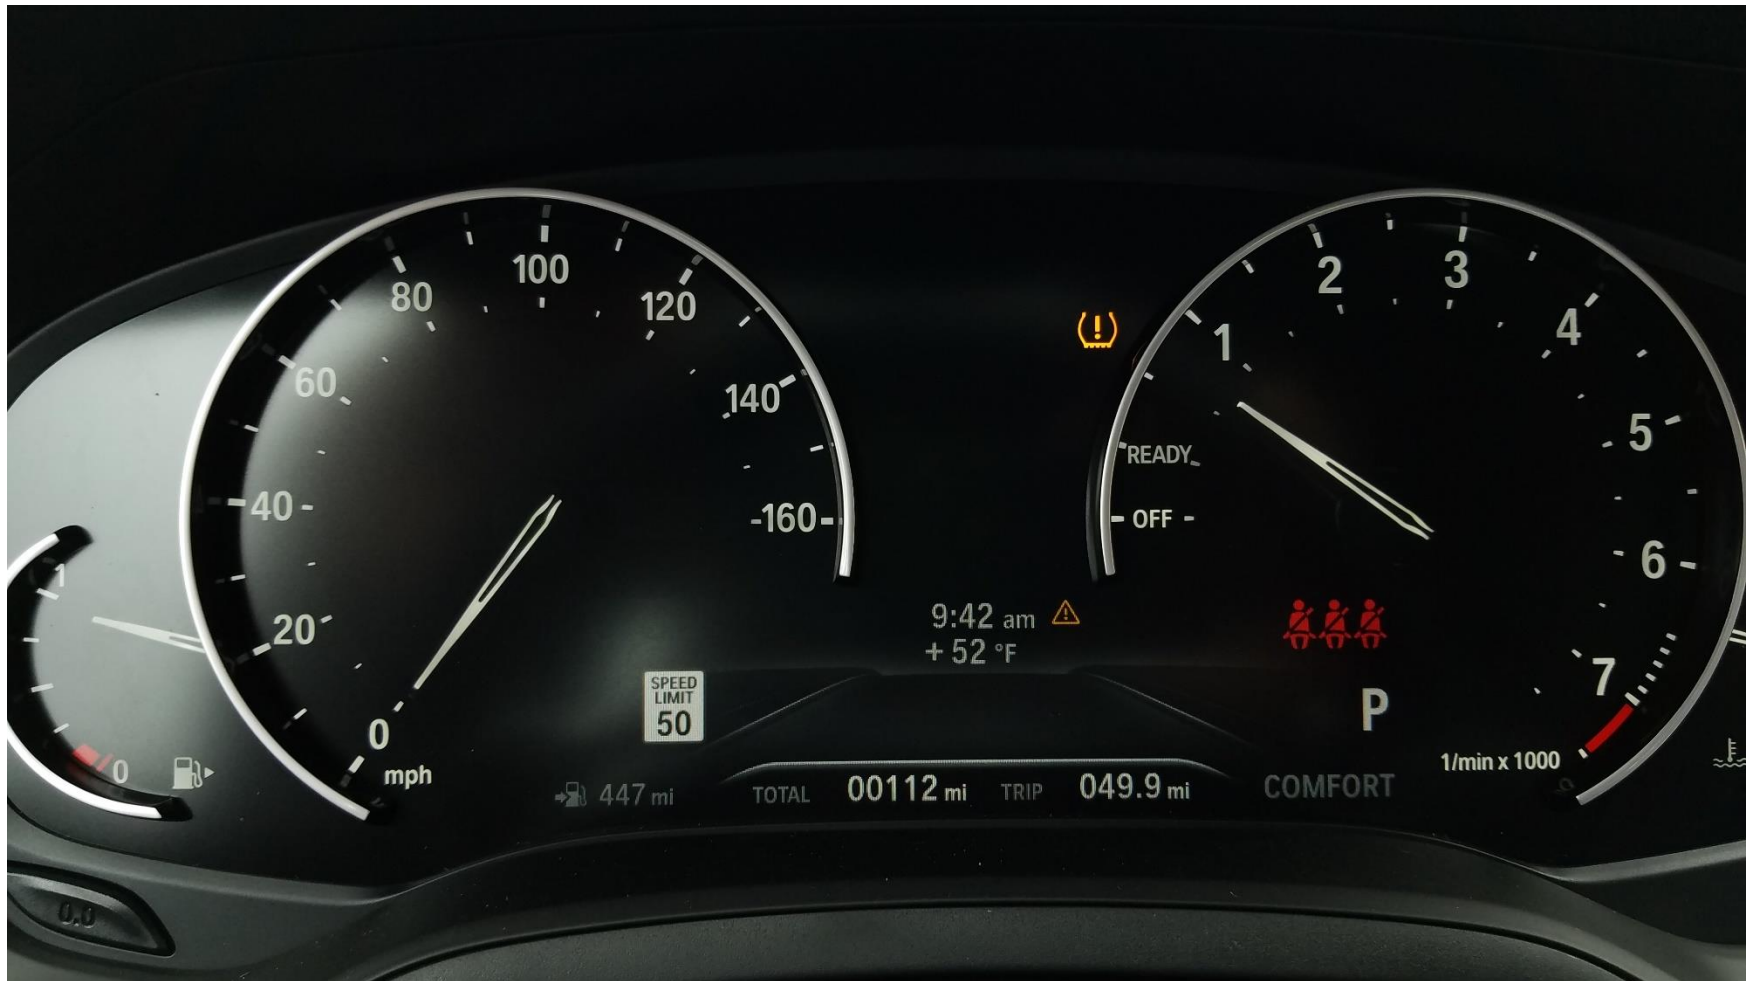
FIGURE 5.17  
TPMS LOW TIRE PRESSURE TELLTALE ILLUMINATION
